HYGIENIC PULSATION DAMPERS AND SURGE ABSORBERS

Designed for CIP applications in the Pharmaceutical, Food, Confectionary, Personal Care Products, Beverage and Brewing Industries

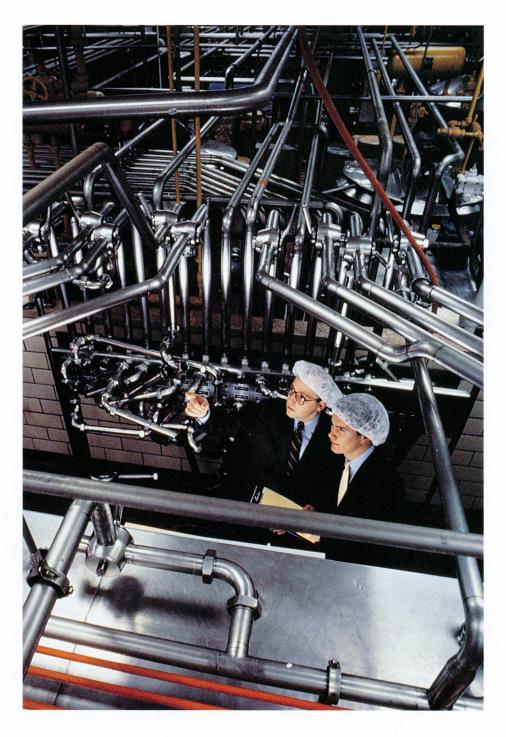
Flowguard pulsation dampers consist of a vessel which contains a volume of inert gas, usually air or nitrogen, at a particular pressure ('pre-charge' pressure). The gas is retained by a flexible membrane within the vessel and process liquid is accessible to the other side. When the pump is on its delivery stroke, part of the flow is displaced into the damper causing a pre-determined rise in pressure to a level dictated by the size of damper selected. On the suction stroke this liquid is released back into the line allowing pressure to fall. Consequently a small amount of liquid enters the damper at the 'peak' of each pulse and is returned to the line when the following 'valley' occurs resulting in the pressure pulsations being absorbed. The slight residual pressure fluctuation is known as the 'level of damping' and is selected to suit the application.

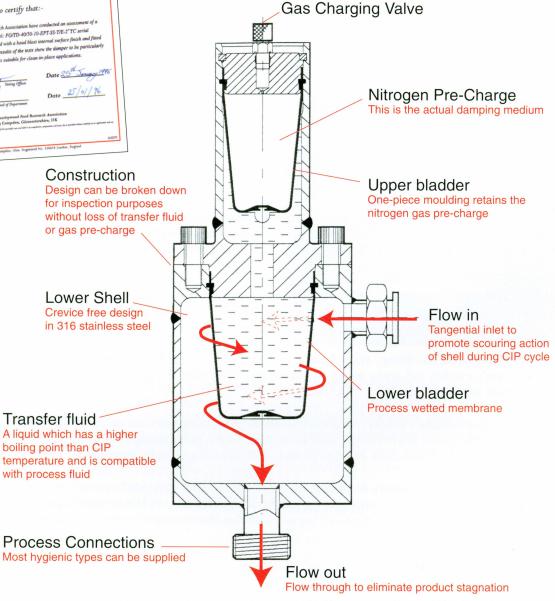
FG/TD HYGIENIC DESIGN

Installation. This should be vertically either up or down with care being taken to ensure that air trapping will not occur as this may prevent proper cleaning. For use as a pulsation damper it should be located as close to the pump as possible. For surge applications the unit should be fitted just before the cause of the surge.

Model Volume Diameter Length Weight (litres) (mm) (mm) (Kg) FBTD-10 0.1 130 280 15 FBTD-20 0.25 140 341 25 FBTD-30 0.5 165 403 35 FBTD-40 1.0 190 428 50 2.0 FBTD-50 228 608 80 FBTD-60 5.0 279 715 150 FBTD-70 10 380 780 250

The FG/TD design was designed with the food, beverage and pharmaceutical industries in mind. It is a double membrane or transfer damper and is suitable for clean-in-place applications. In tests carried out by Campden & Chorleywood Food Research Association to the EHEDG protocol it was found to clean better than the reference pipe.

The use of two membranes which are hydraulically connected with a transfer fluid overcomes the problems of crevices and product stagnation which are inherent in most other damper designs. To ensure efficient cleaning during the CIP cycle it is a true flow through design with the product wetted lower shell being crevice free and having no small corners or dead areas. It is normally manufactured in 316 stainless steel with a choice of food quality materials for the lower (process contact) membrane. The side inlet port is attached tangentially to promote a scouring action of the shell during cleaning and the unit can be partially dismantled for inspection of the lower shell and membrane - the process wetted parts - without loss of precharge pressure or transfer fluid.
